# Typical Defects in Elastomeric Expansion Joints

# Bridge Expansion Joints

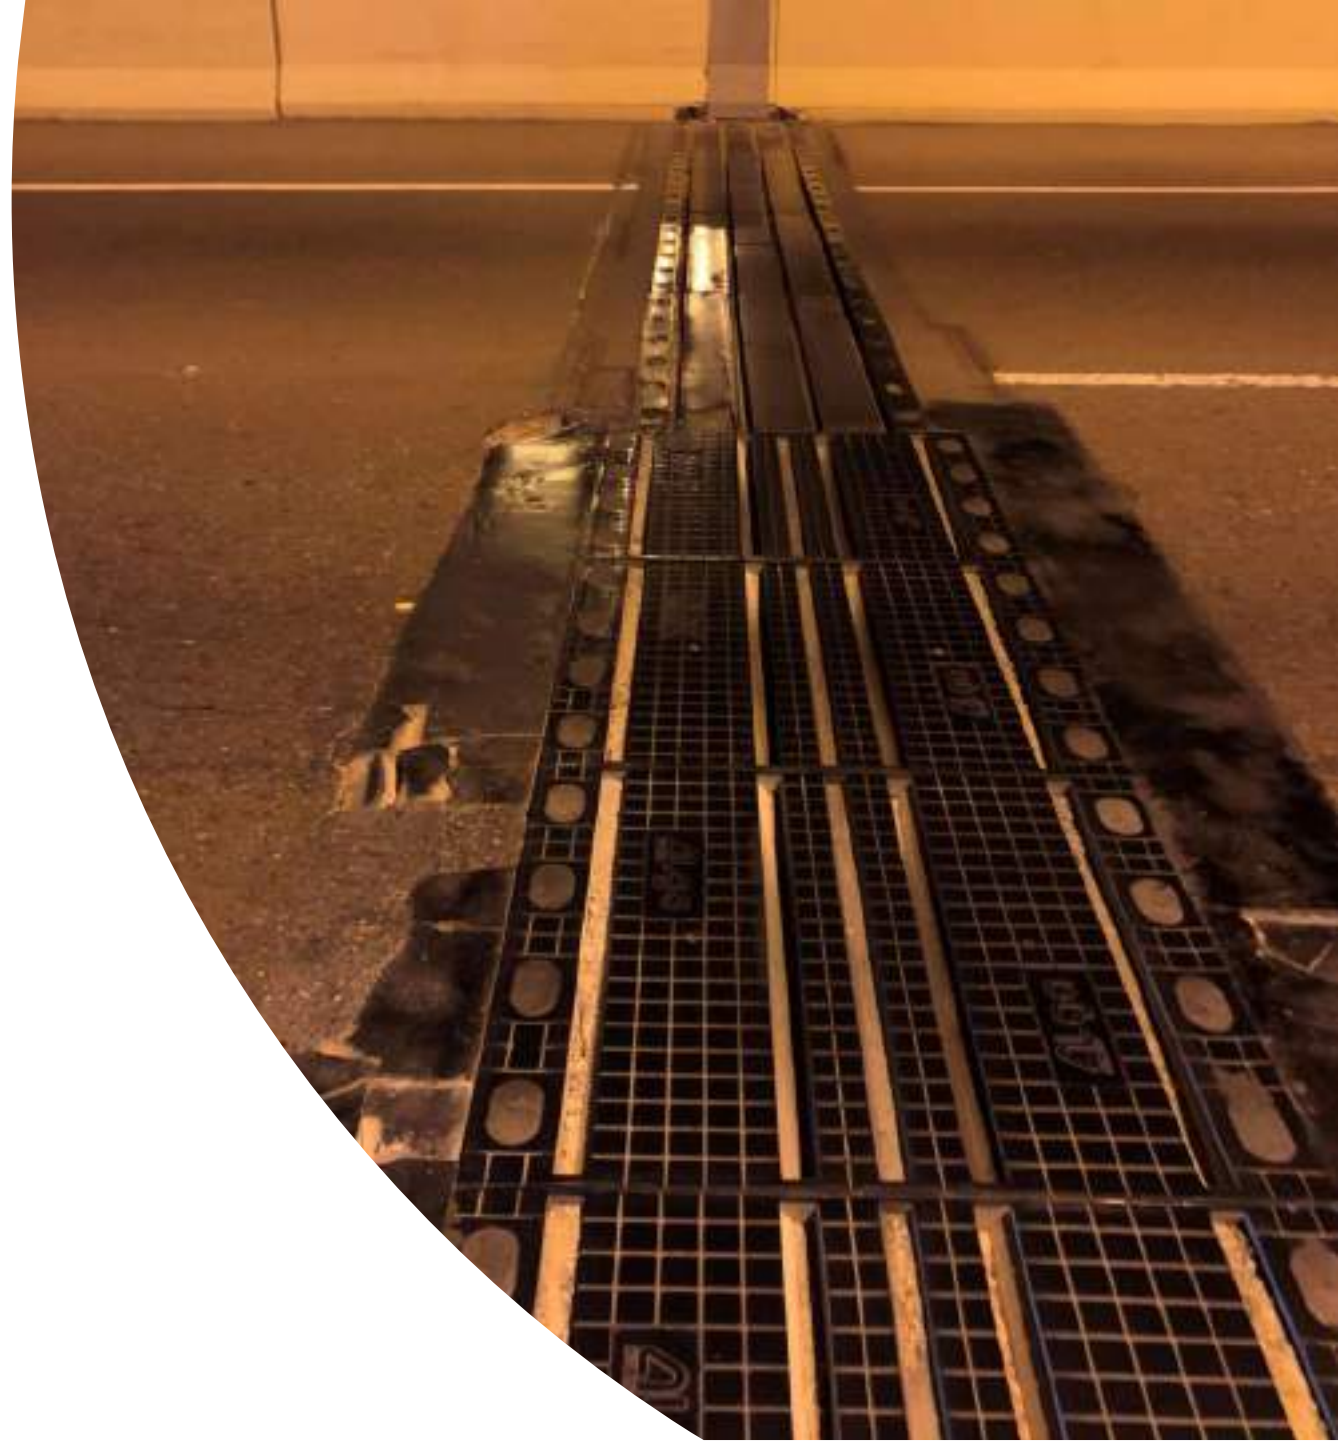
## **Breaking up or cracking of transition strips**

*This is generally caused by the transition strip becoming debonded, either from the surfacing or from the deck or abutment. Once debonded, the edge will be unsupported, and start to break up. This can happen to the transition strip and adjacent surfacing*

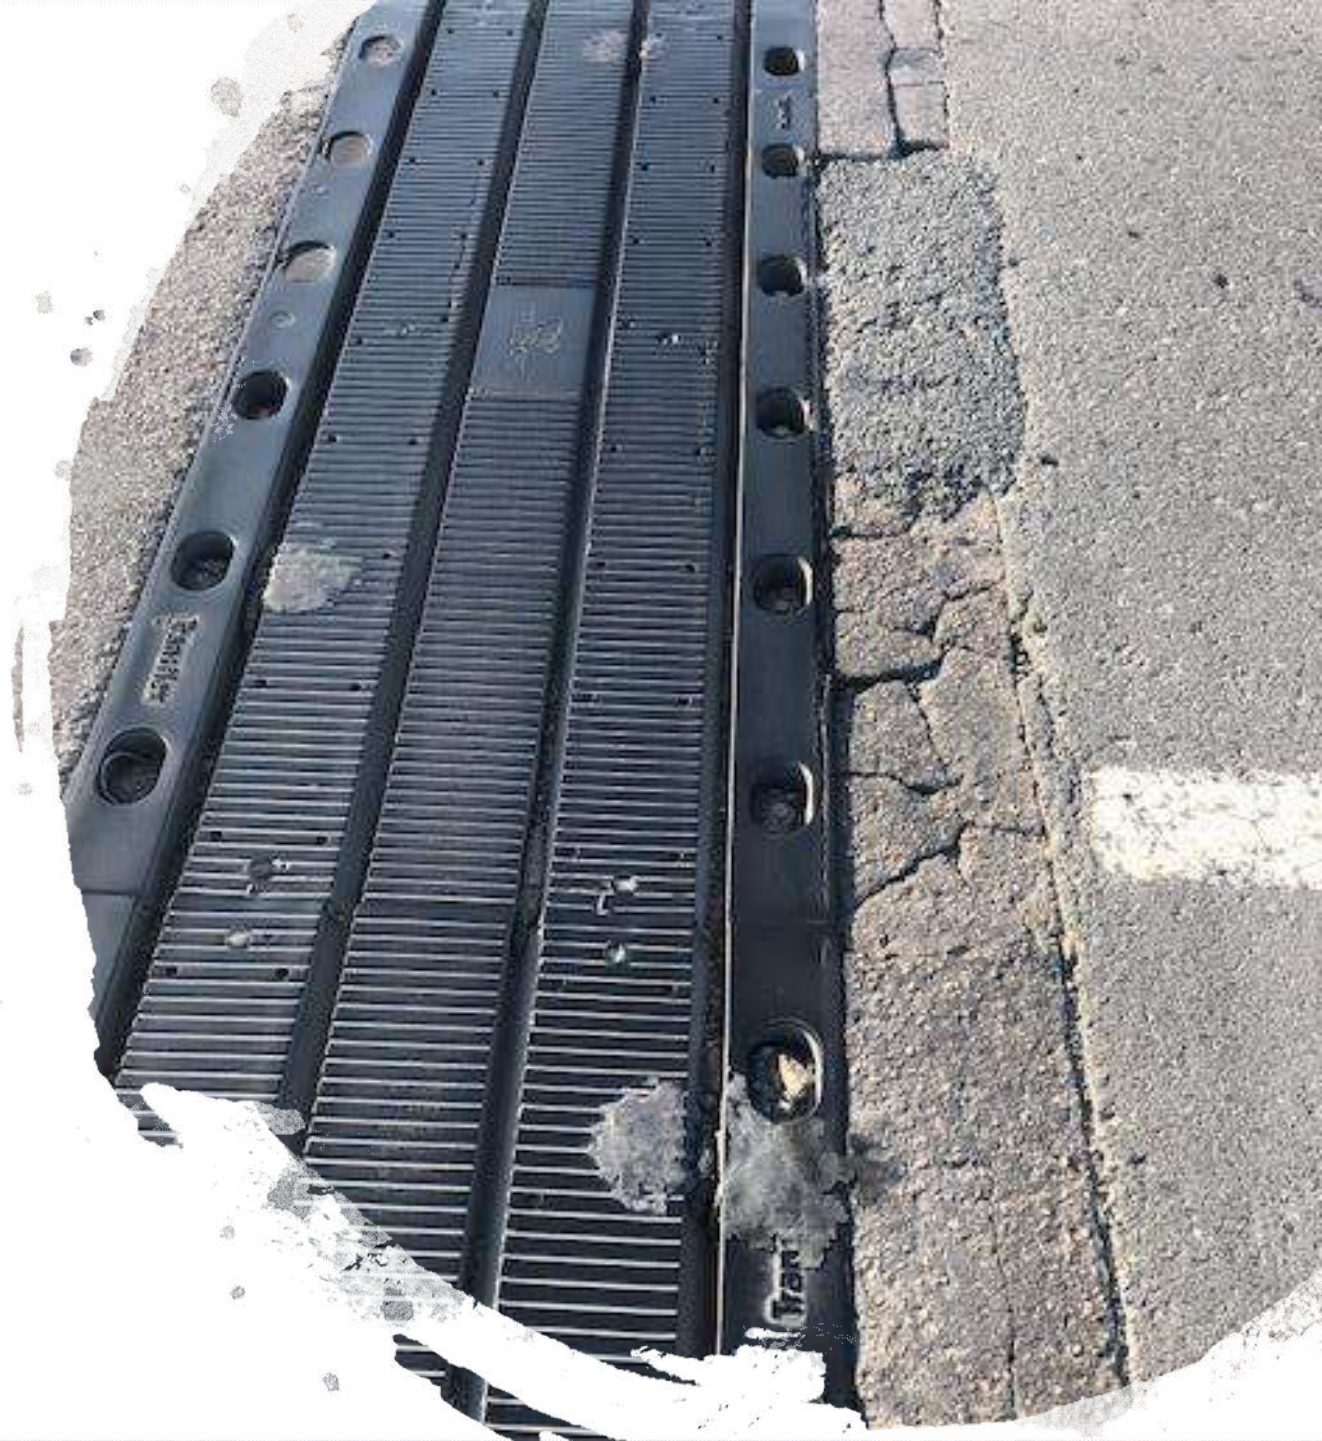
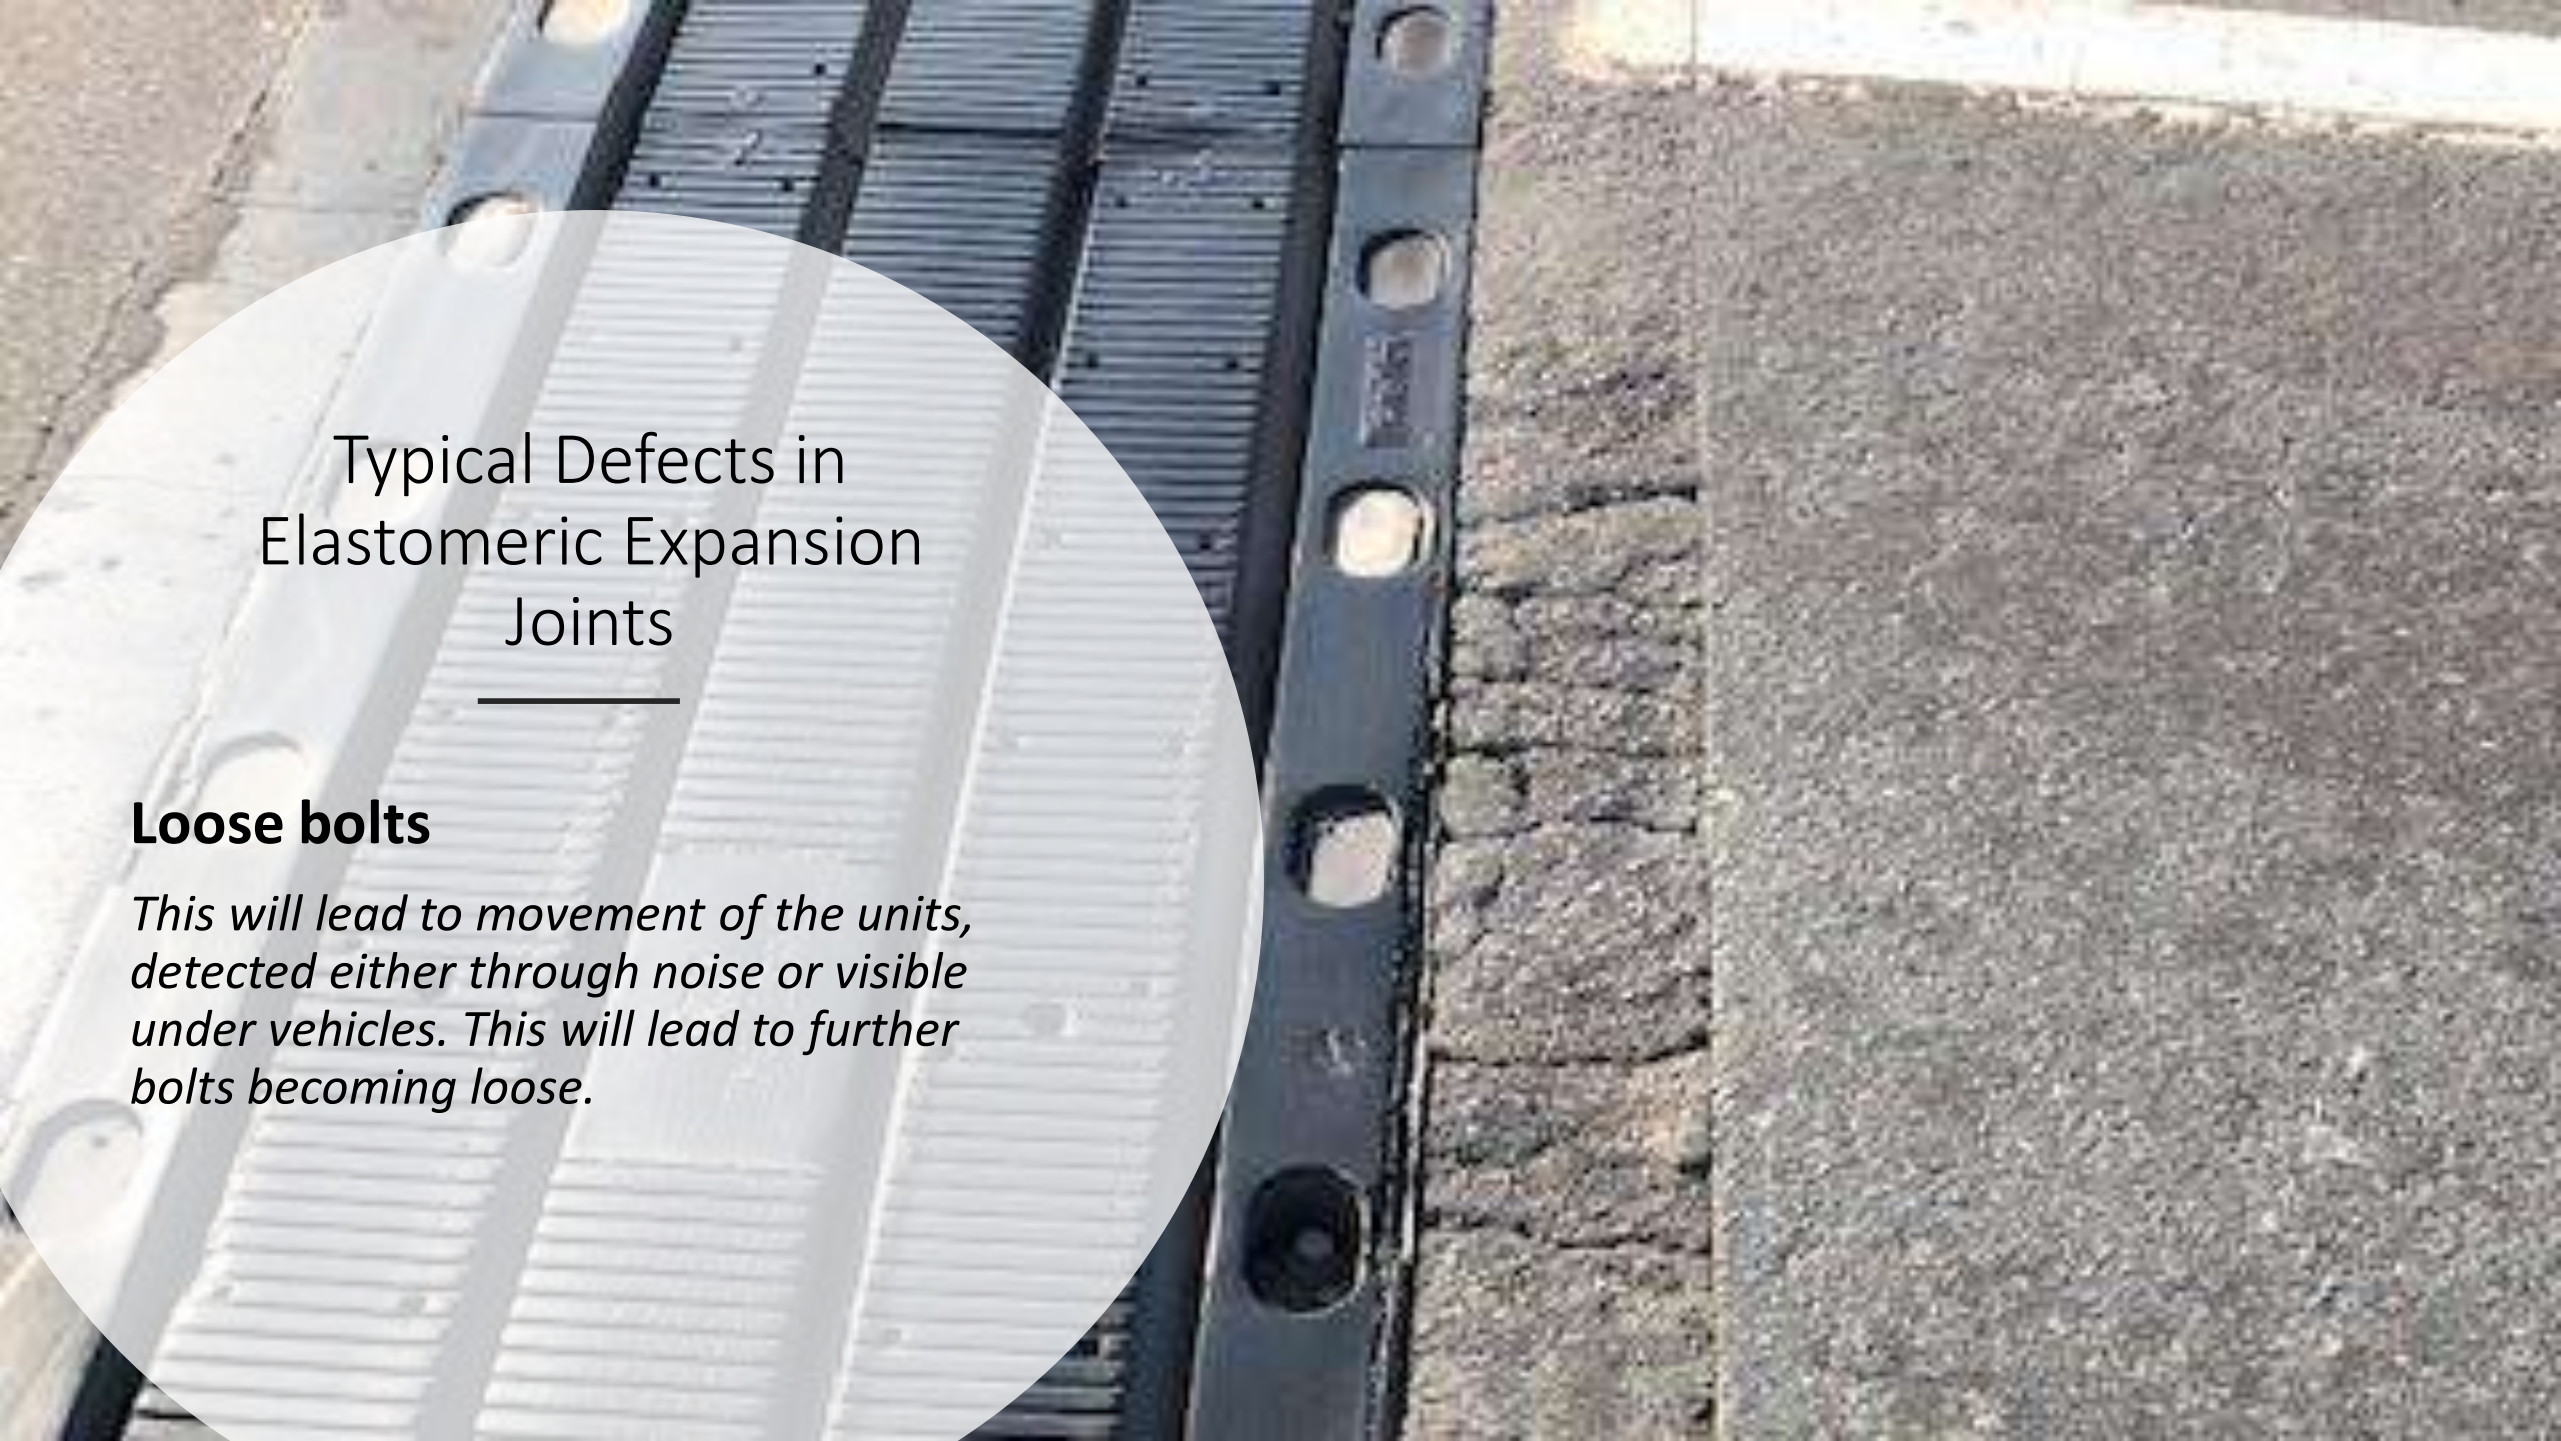
### **Missing bolt cover**

*The cover can be flicked out/removed by traffic, leaving the bolts underneath exposed. Corrosion of the bolts will lead to premature bolt failures*

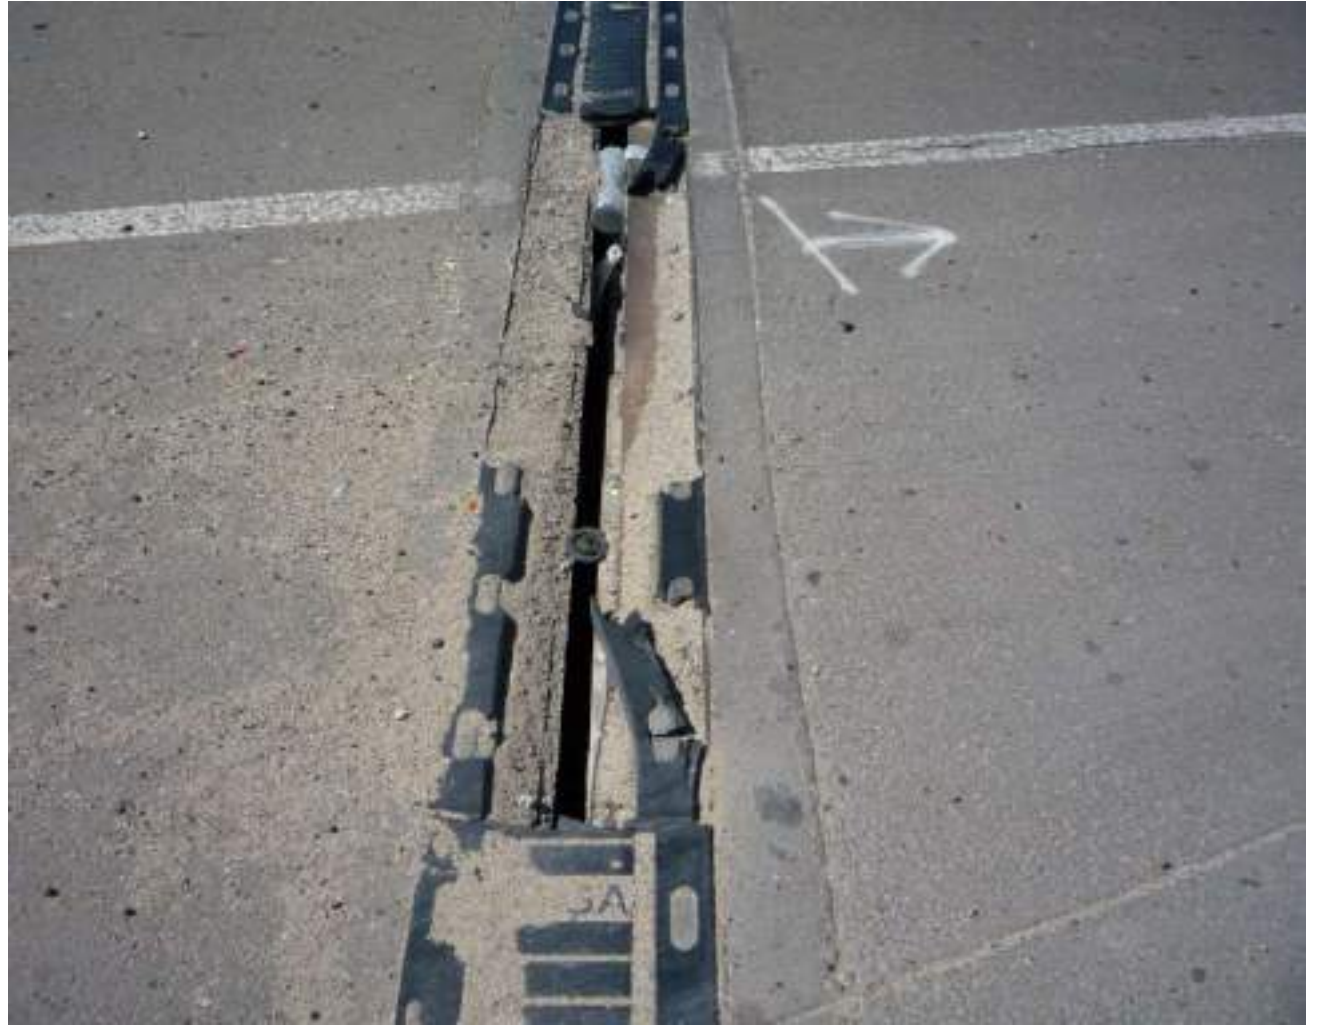
## **Bolt failures causing joint to lift**

*Sufficient bolt failures will cause the joint to move under traffic. This will lead to impact damage to the deck below the joint.*

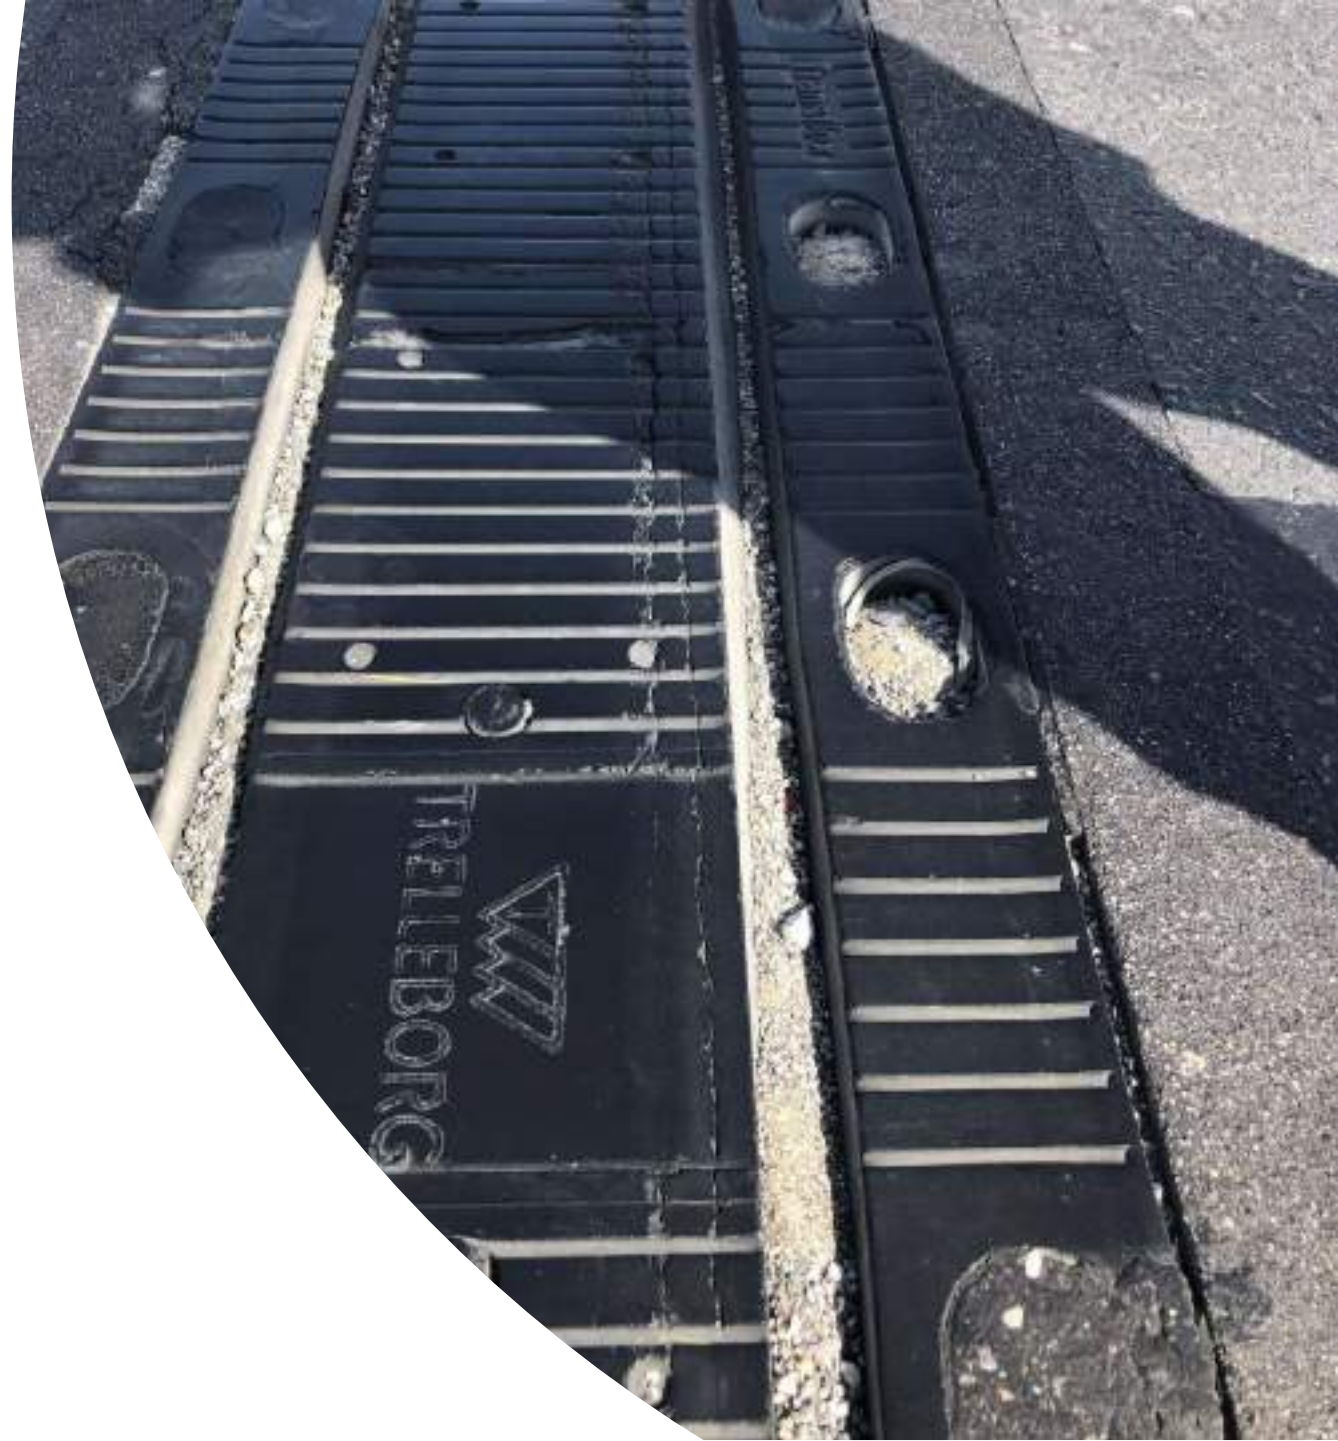
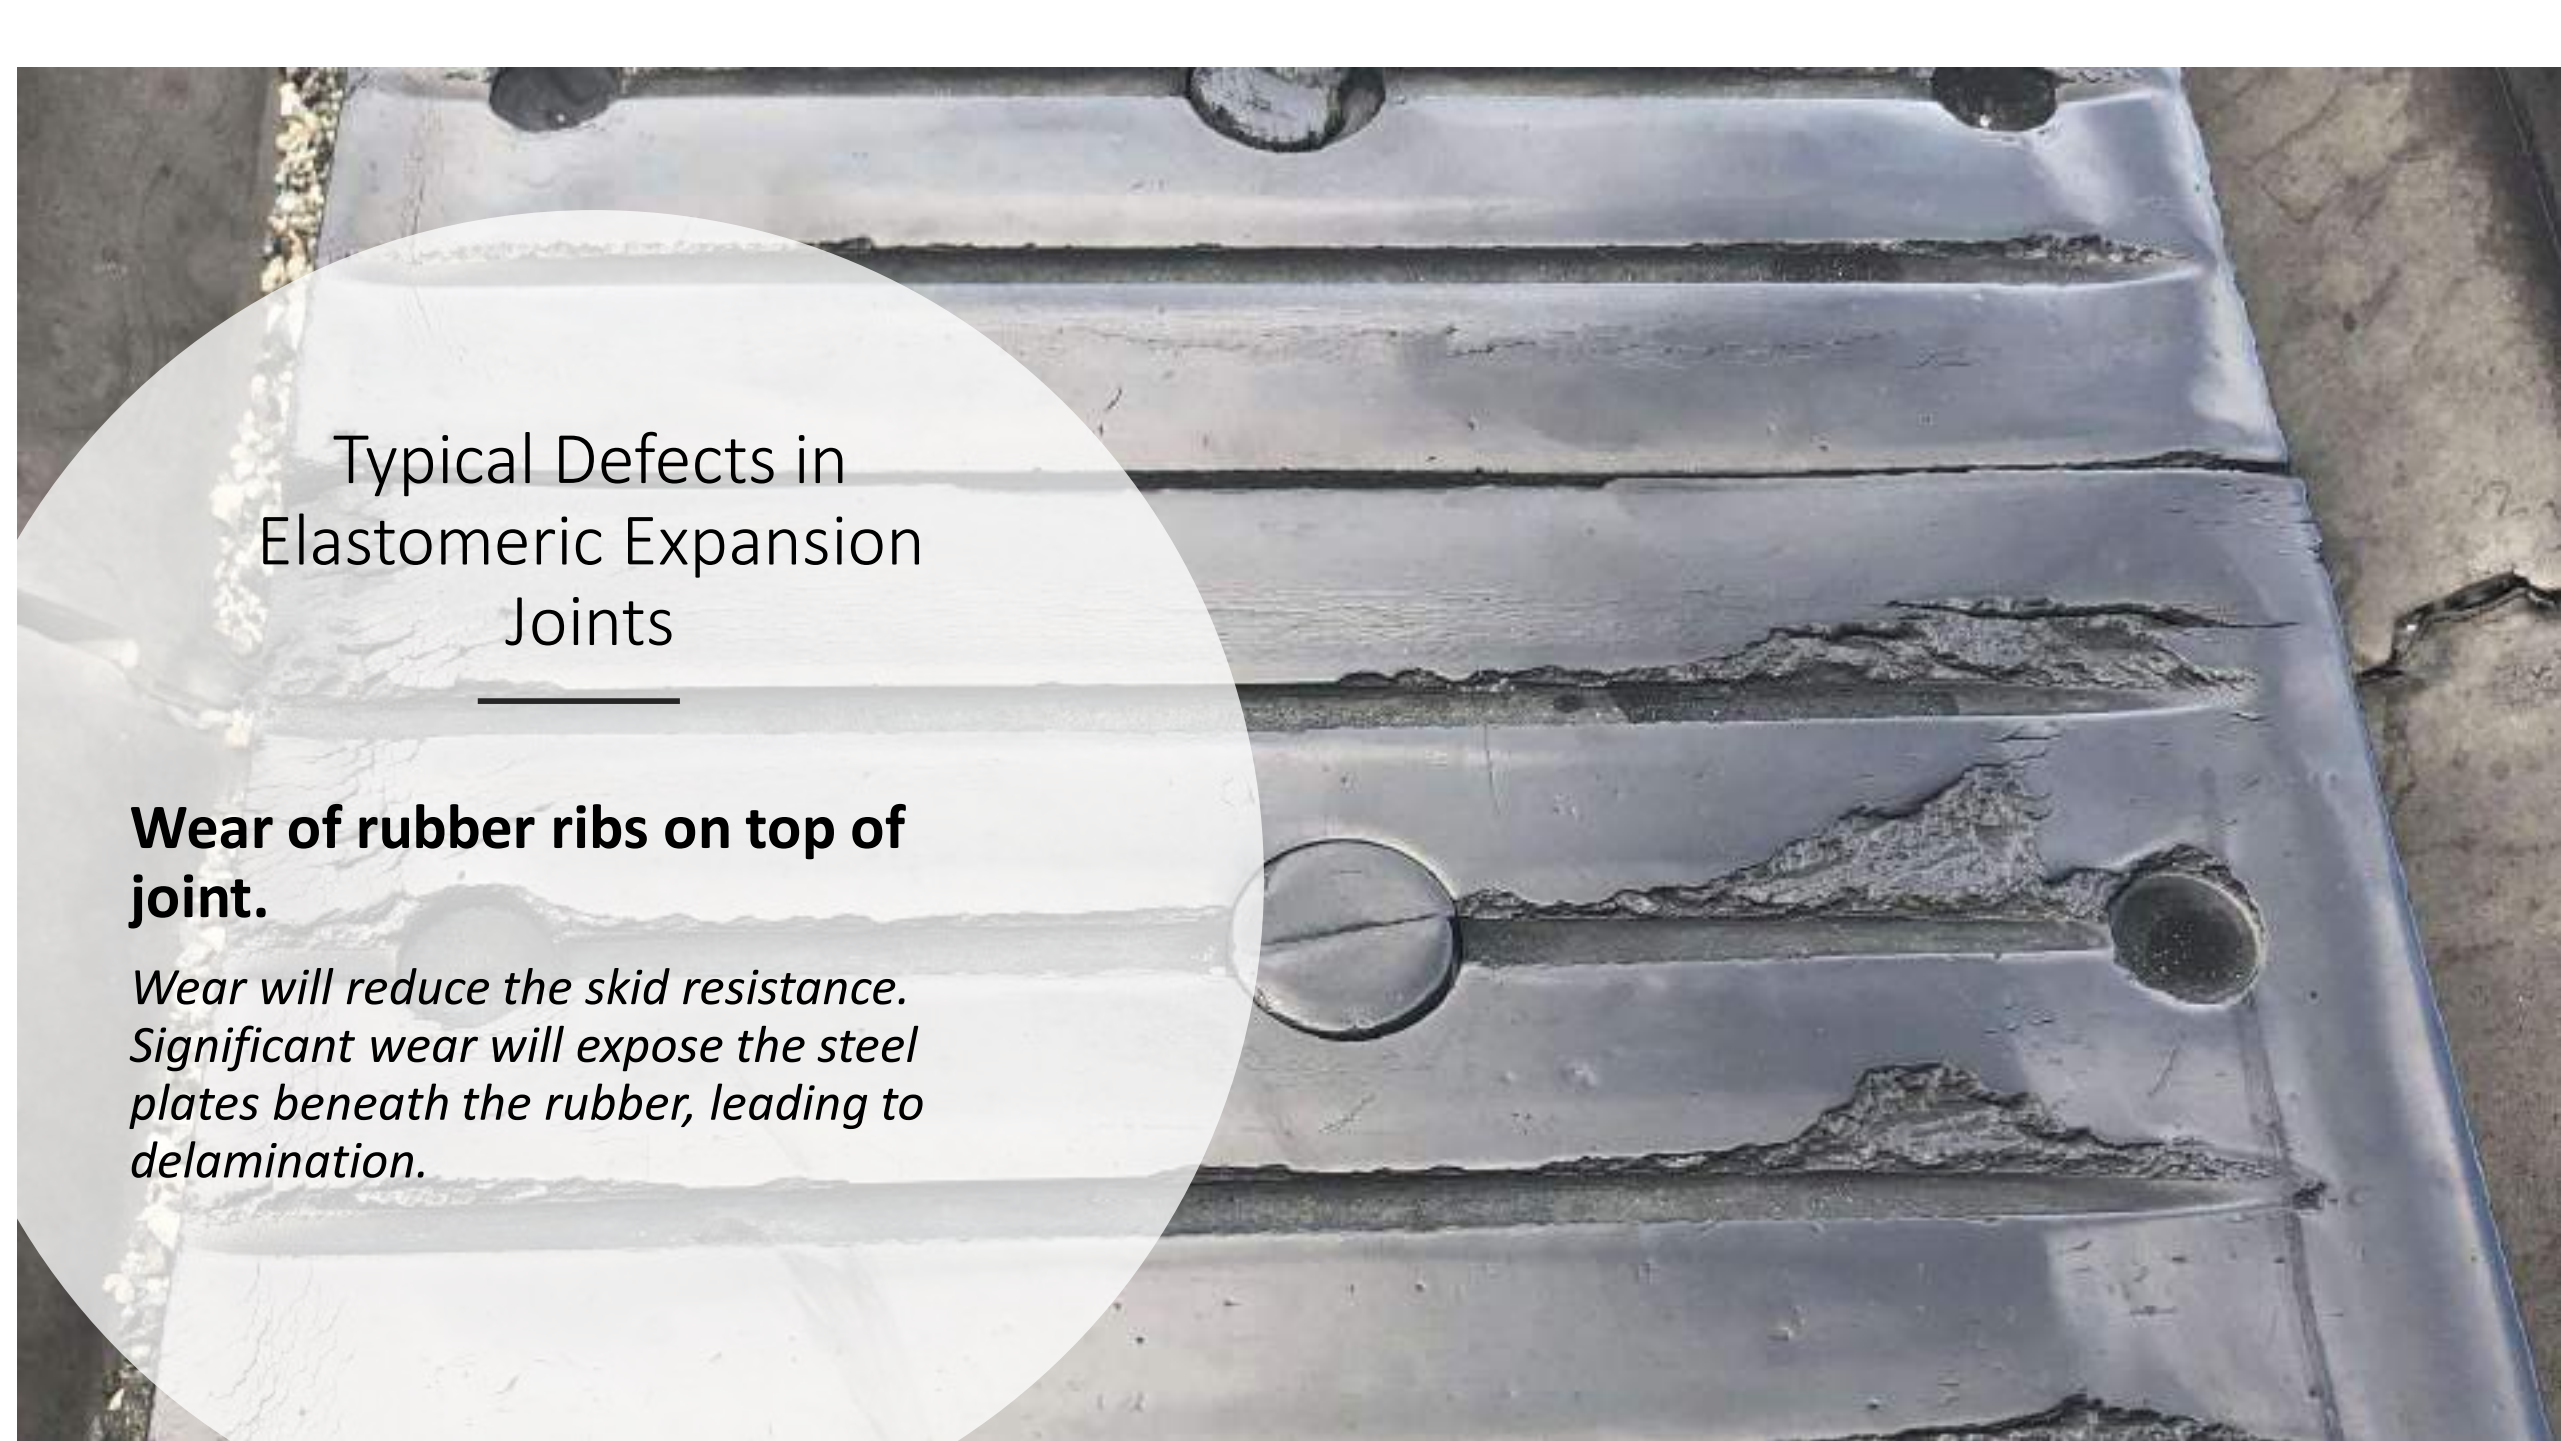
## **Debris in grooves**

*Debris in grooves will restrict movement and under vehicle pressure will wear the rubber.*

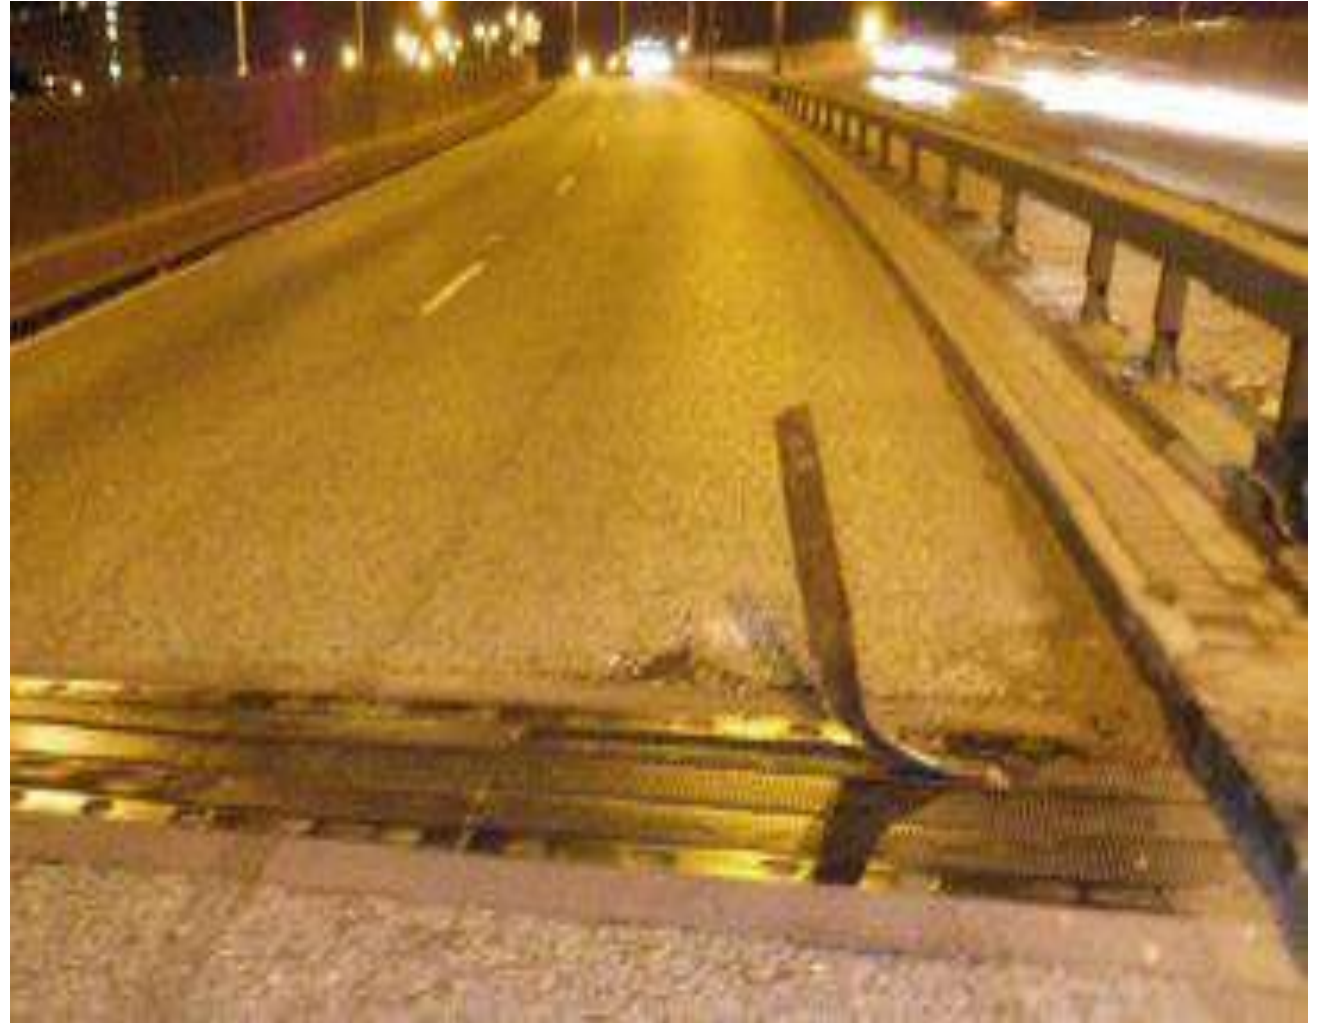
## **Delamination of elastomer/ metal plate interface**

*Heavy wear and tears in the elastomer will result in delamination, exposing the steel plate over significant areas of the joint. The metal is smooth, and so skid resistance will be limited. The exposed metal plate may also lift up, causing an obstruction in the carriageway.*

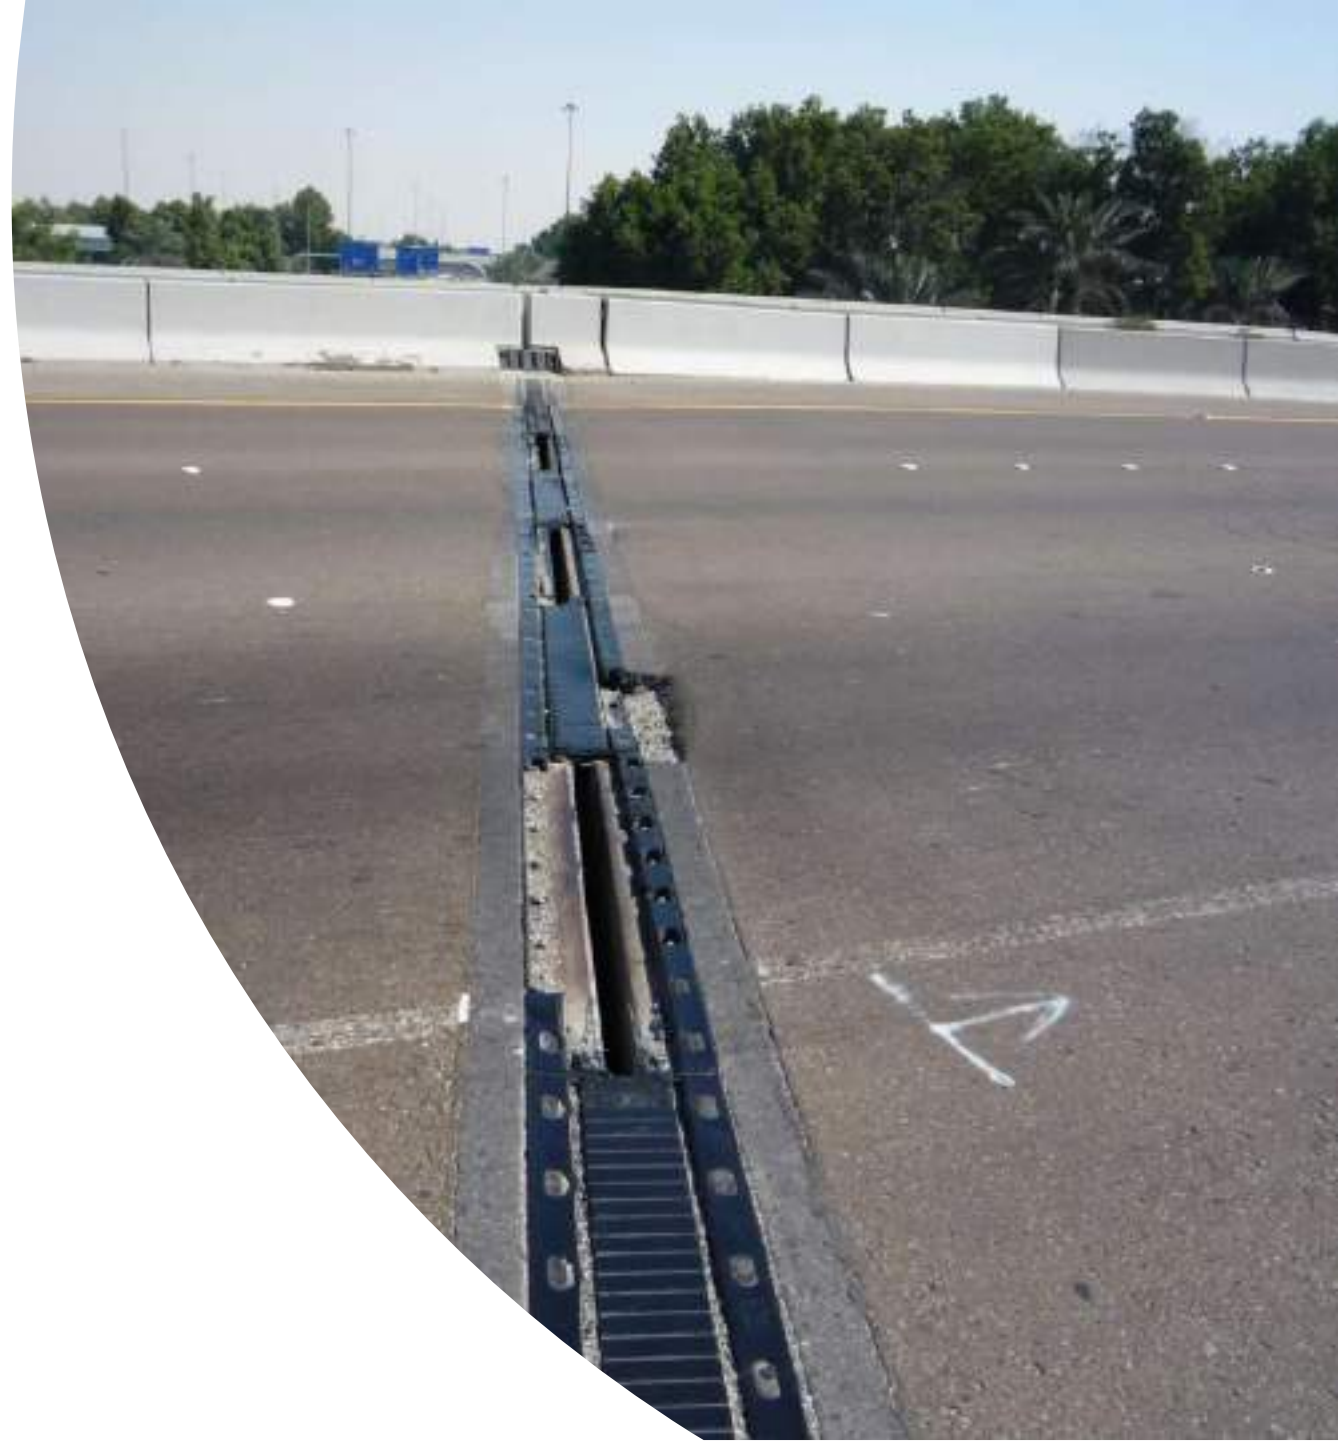
## Leakage

*This could be caused by any of the defects above, or failure of the drainage membrane. The effects could be damage to the carriageway either side of the joint, or early deterioration of the bridge structure*

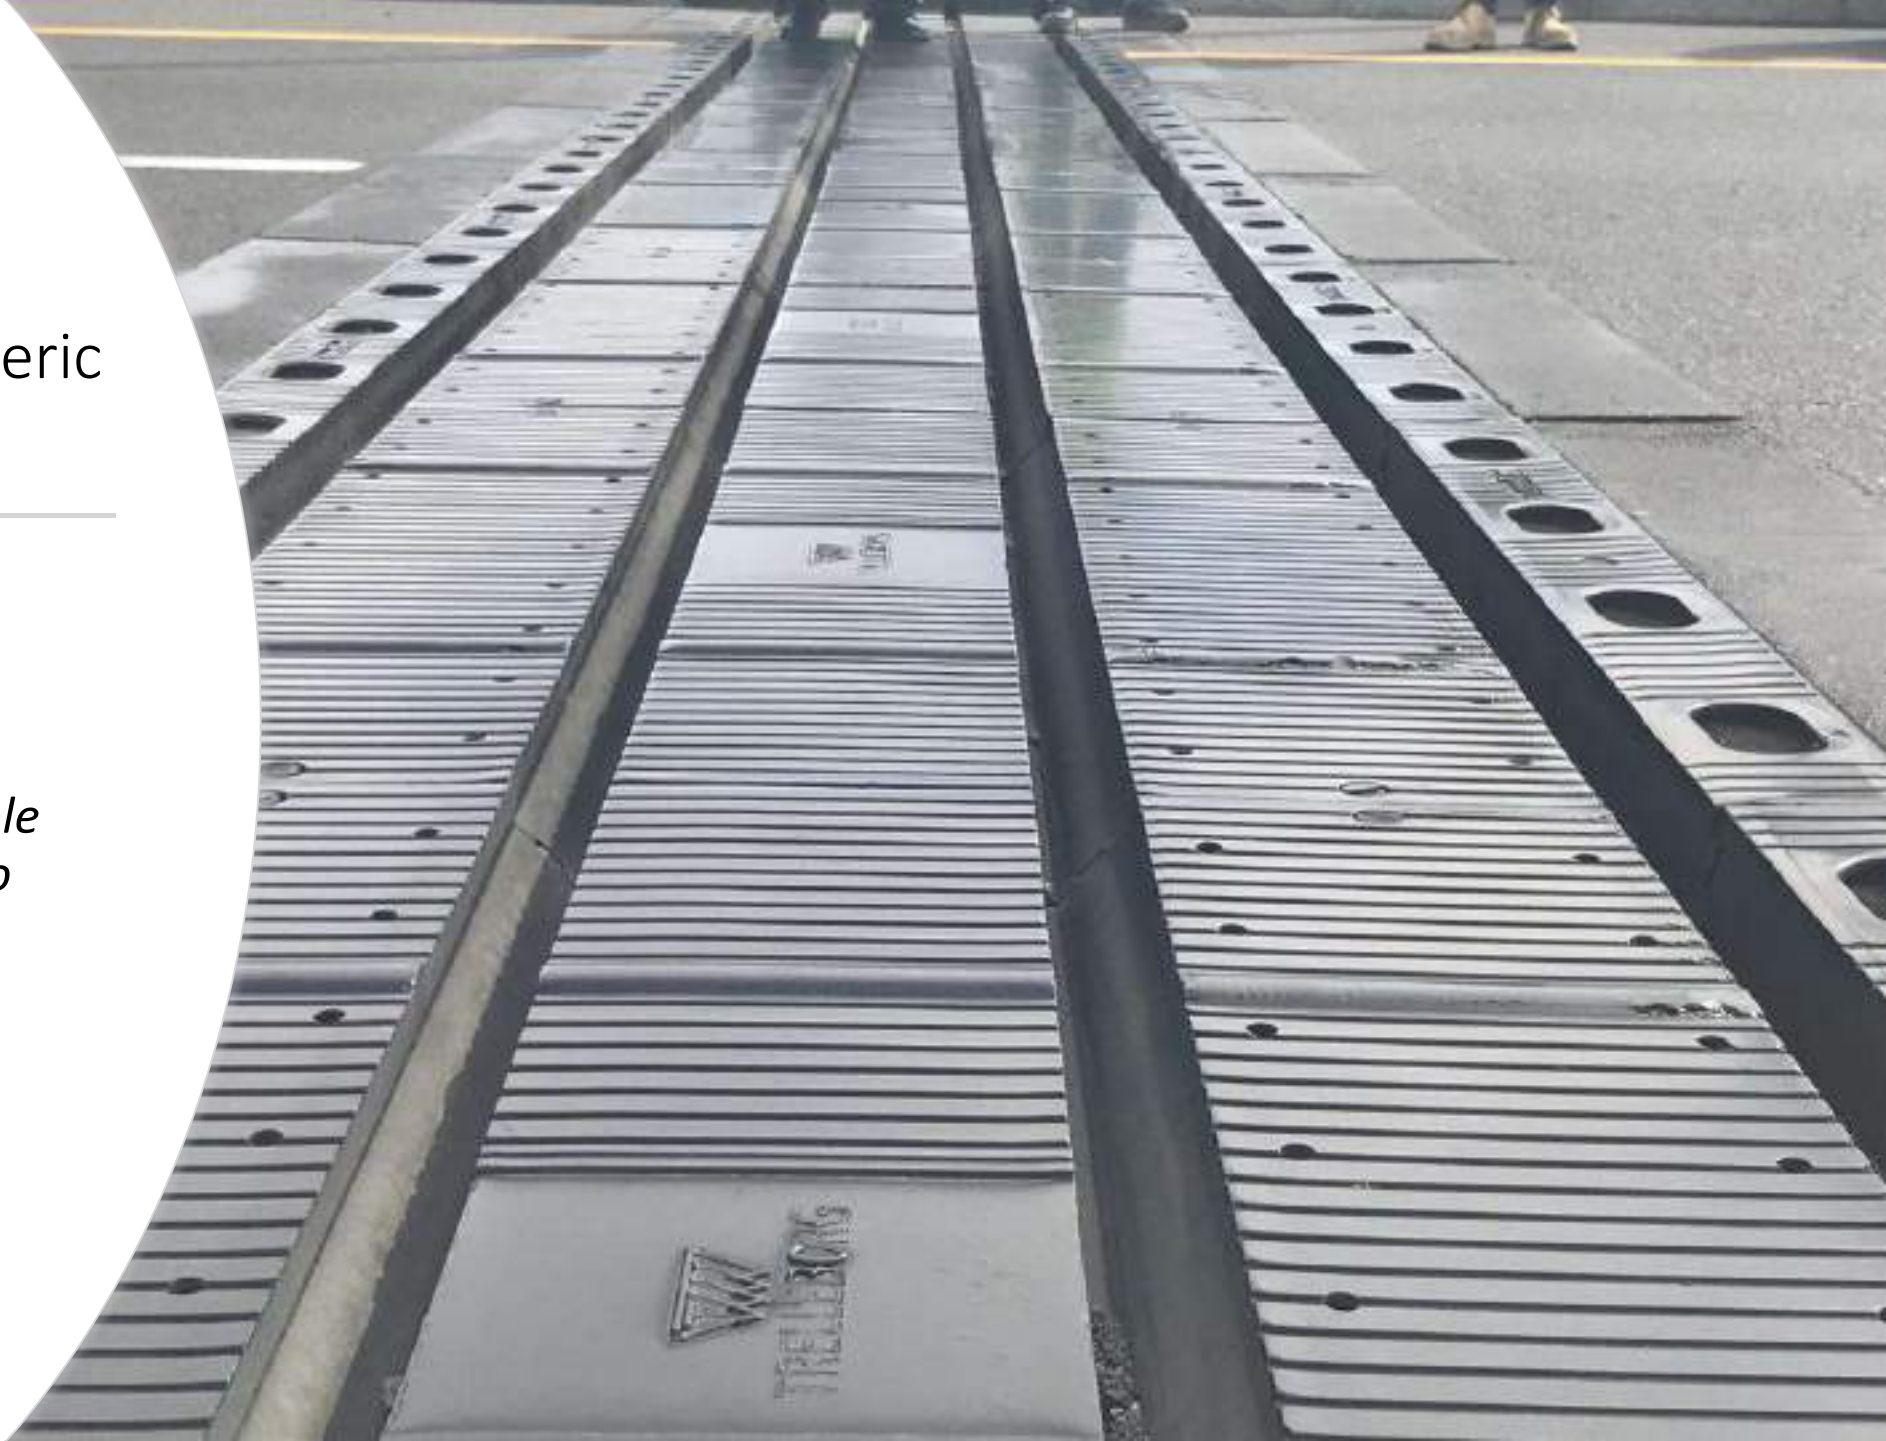
### Sound

*All joint components are in good condition, with no visible signs of defects. There are no cracks or tears visible.*

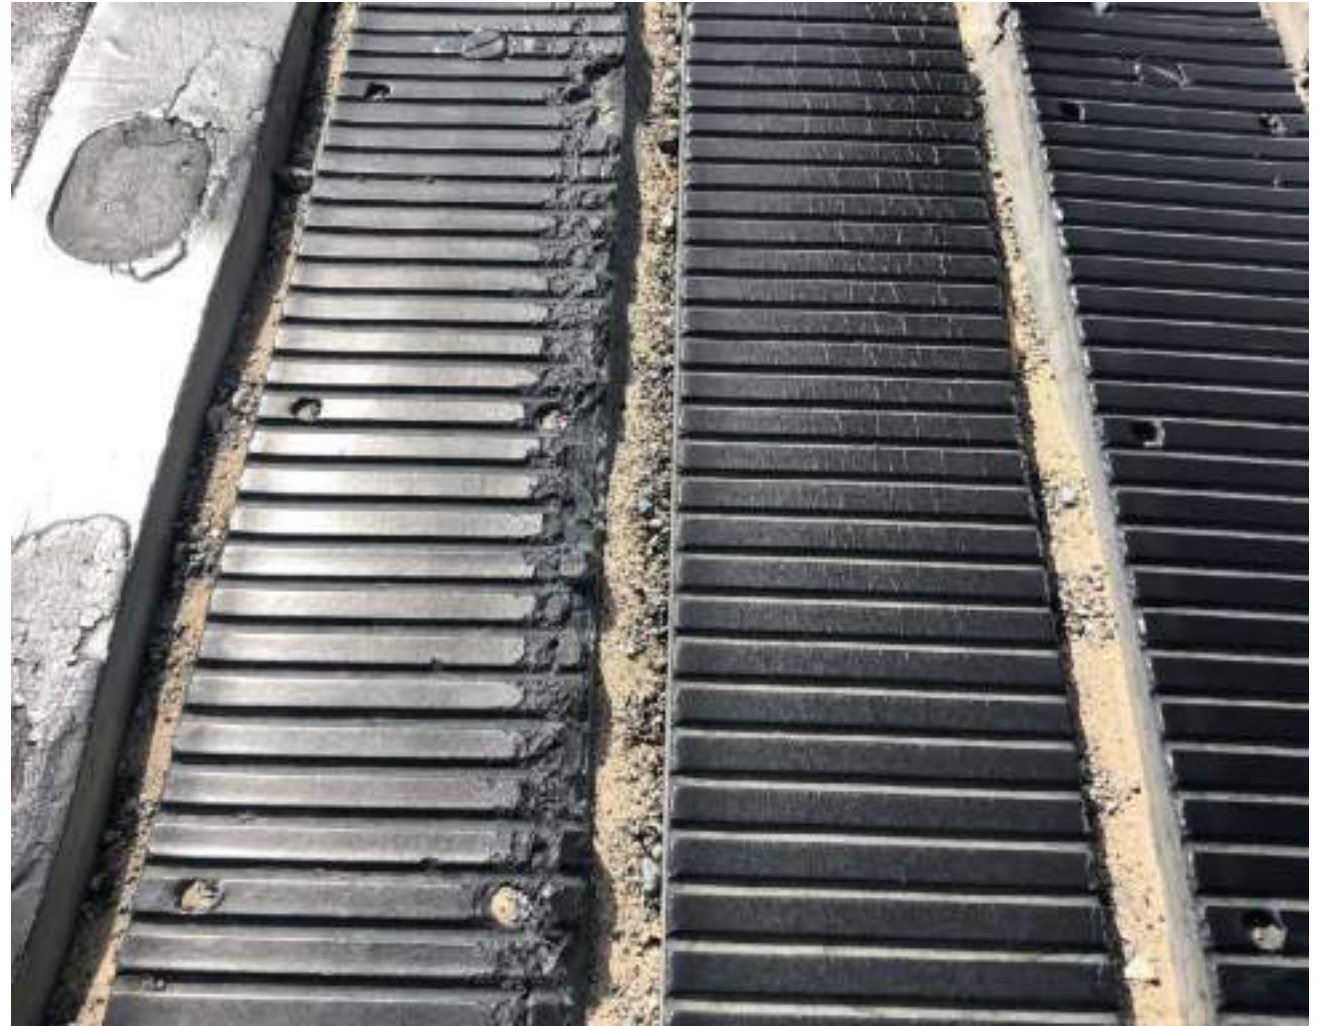
**Crack/tear <20% of width of  
component**

*Cracks and tears are easily visible  
but the joint is still able to function.*

- this unit is in Project R842/2 (Junction 22, Bridge 4 – Abutment 1) . Although the joint is functioning properly, but the manufacturer will supply 13 units to RTA and determine the cause of this.
