# Typical Defects in Elastomeric Expansion Joints

# Bridge Expansion Joints

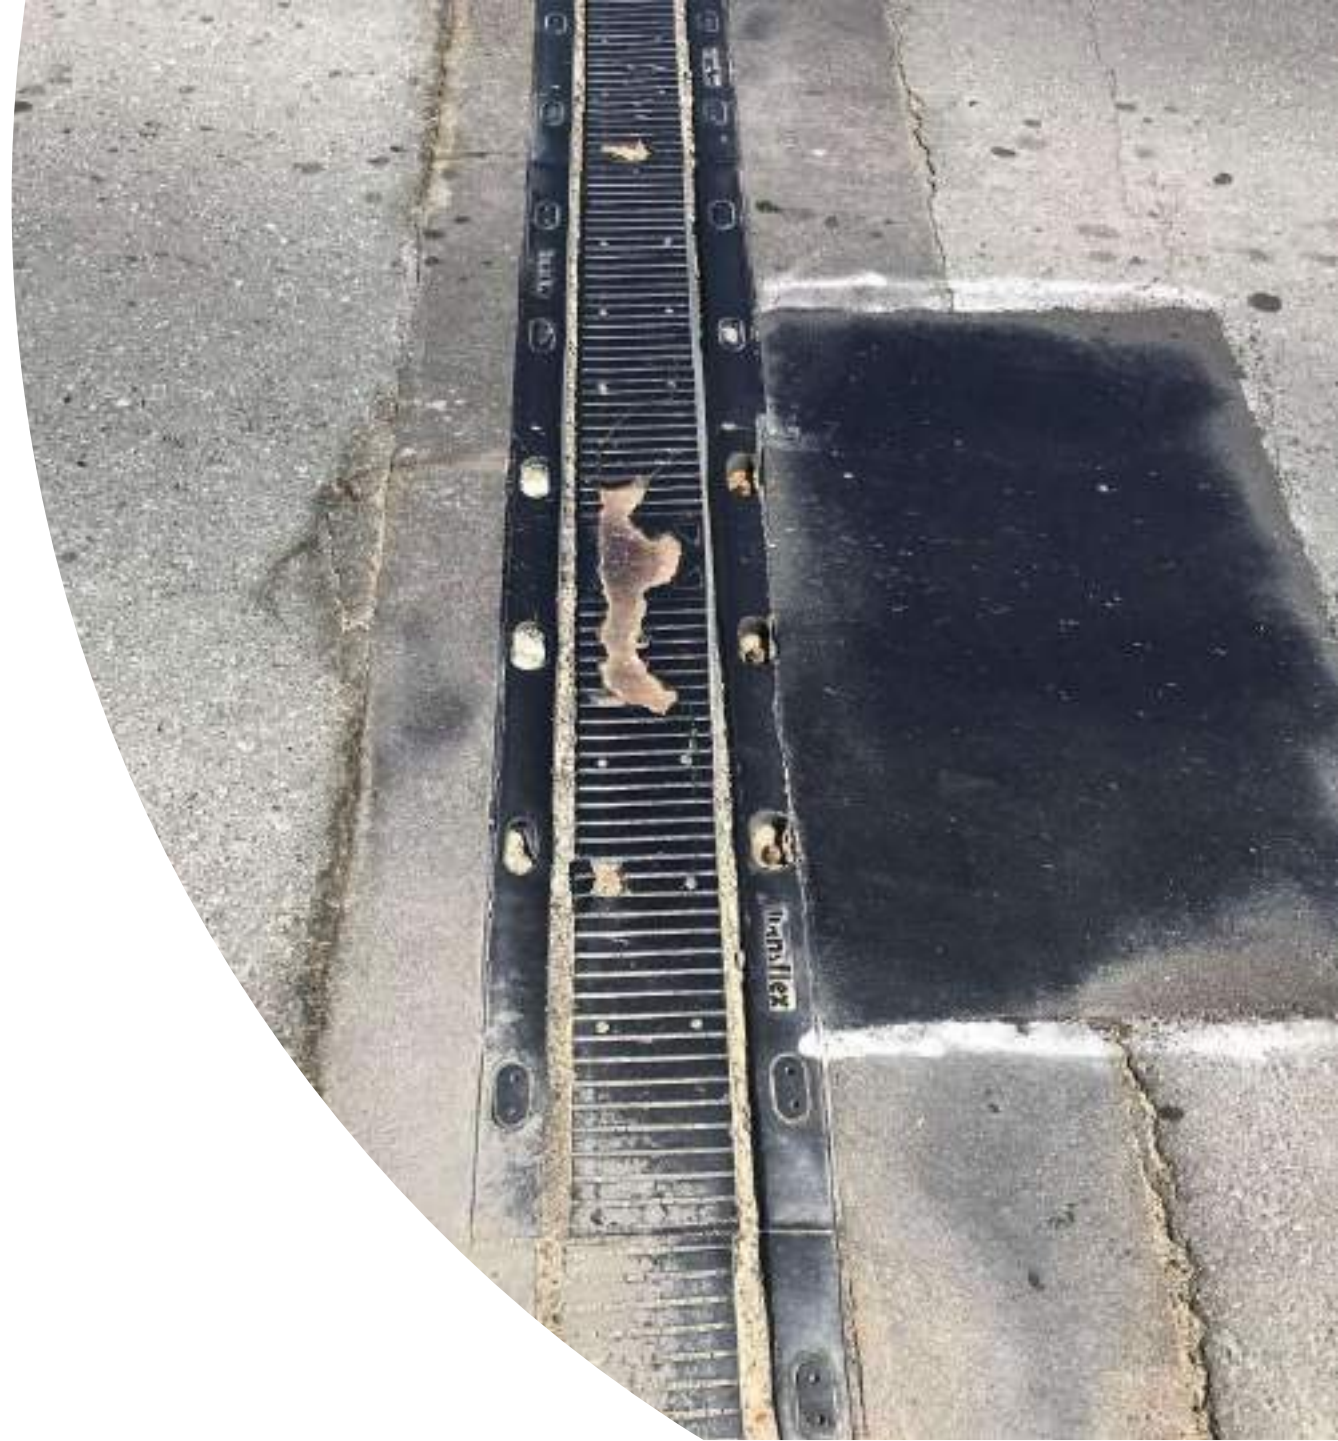
**Crack/tear >20% by <50% of width of component**

*Cracks and tears are significant, but there remains some limited functionality. The steel in the plates is exposed. Complete failure can be expected shortly.*

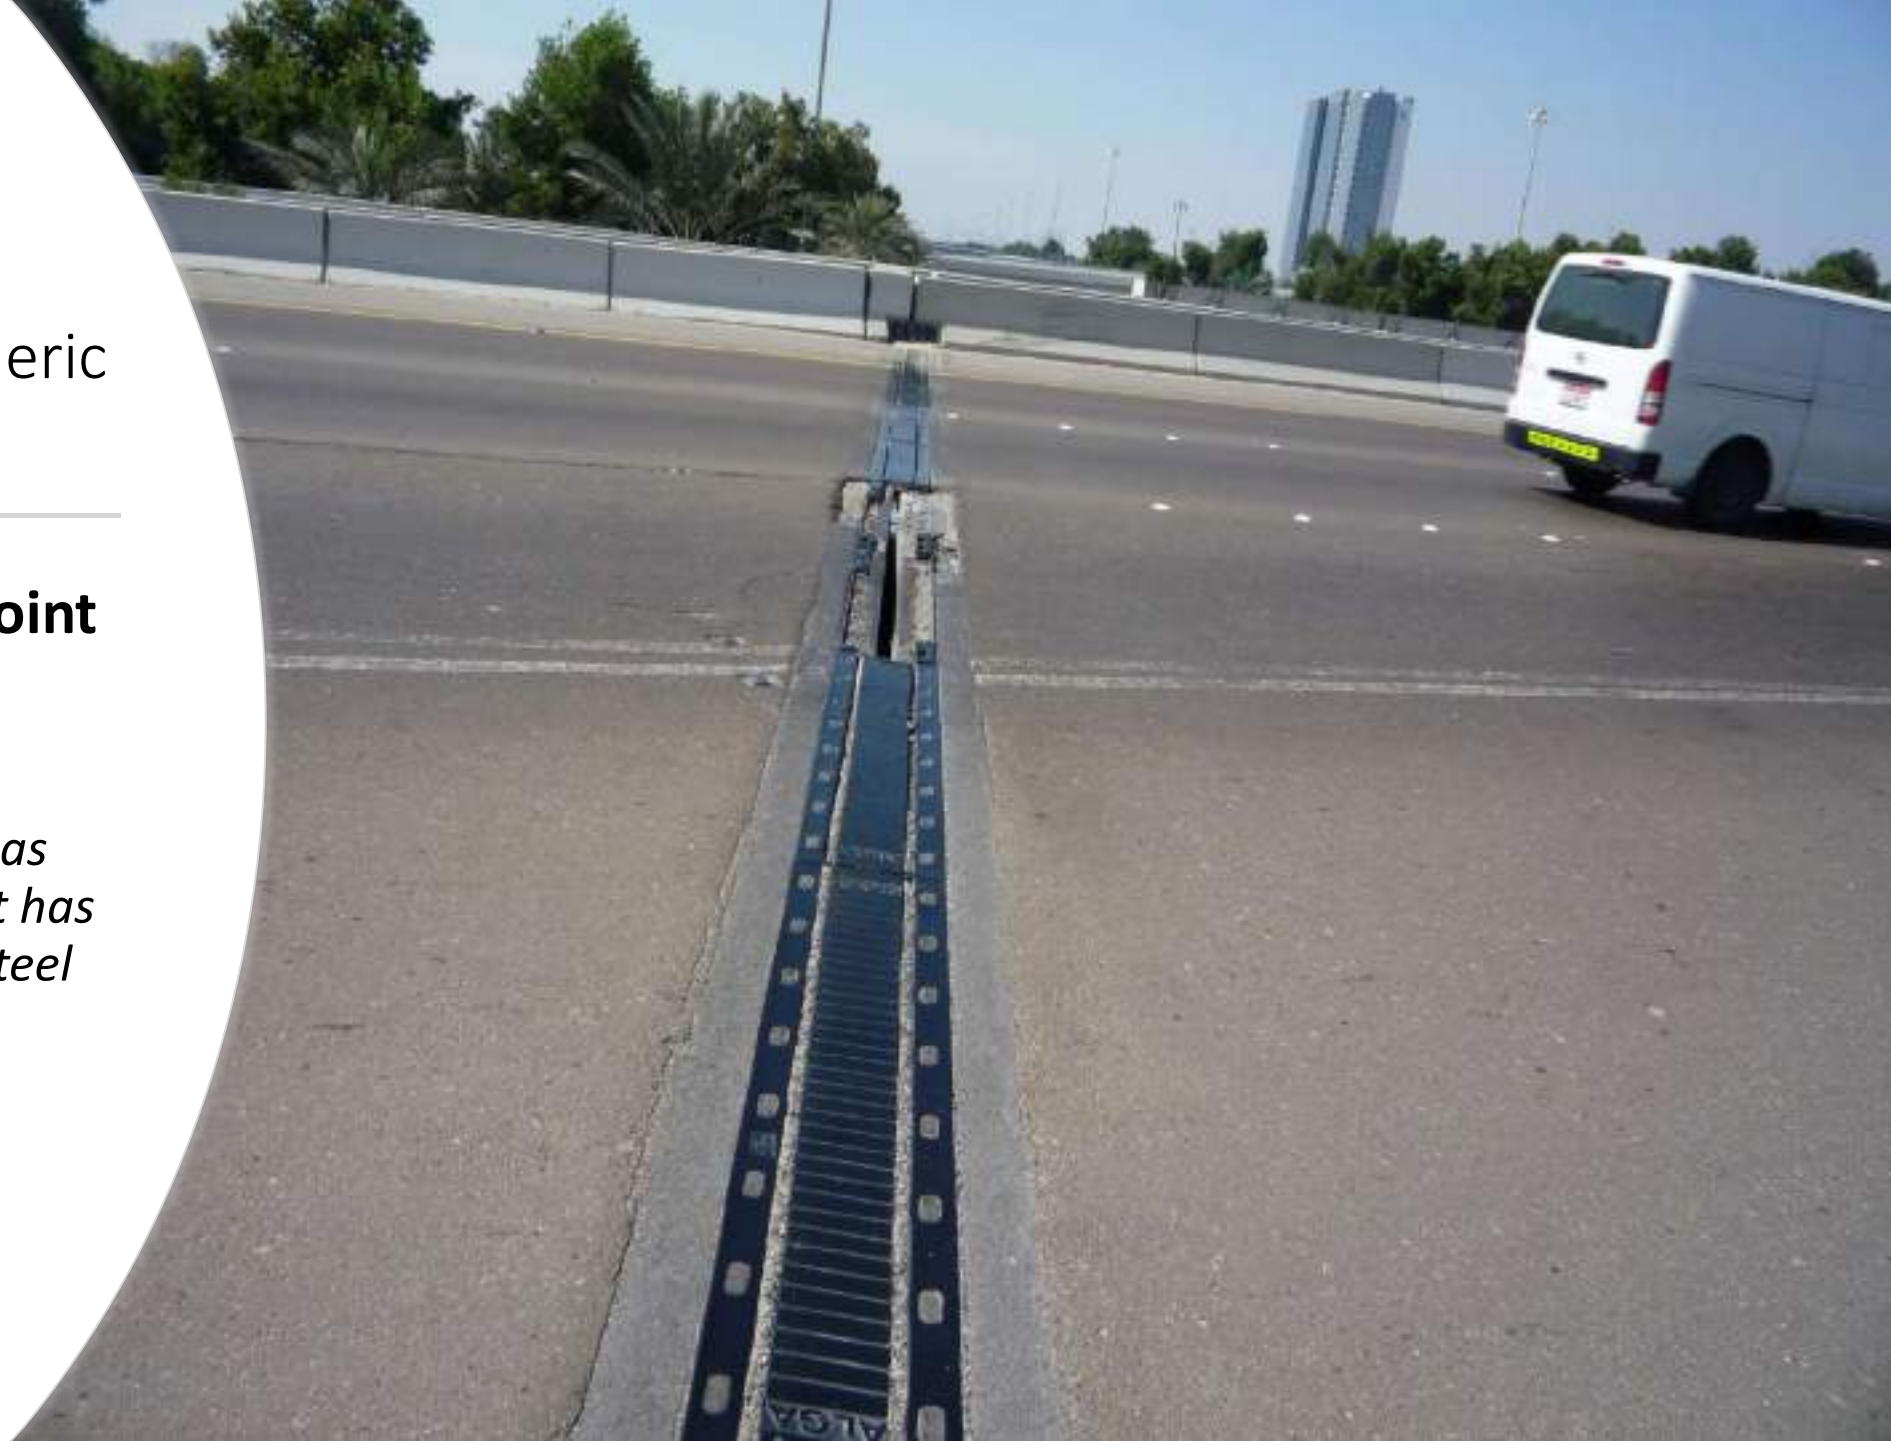
### **Failure of expansion joint component**

*A component of the joint has completely failed. Part of it has detached or is missing. A steel plate is loose or missing.*
